# Installation Assessment Army Base Closure Program

## Kapalama Military Reservation Honolulu, Hawaii

TS-PIC-89334-R  
June 1990

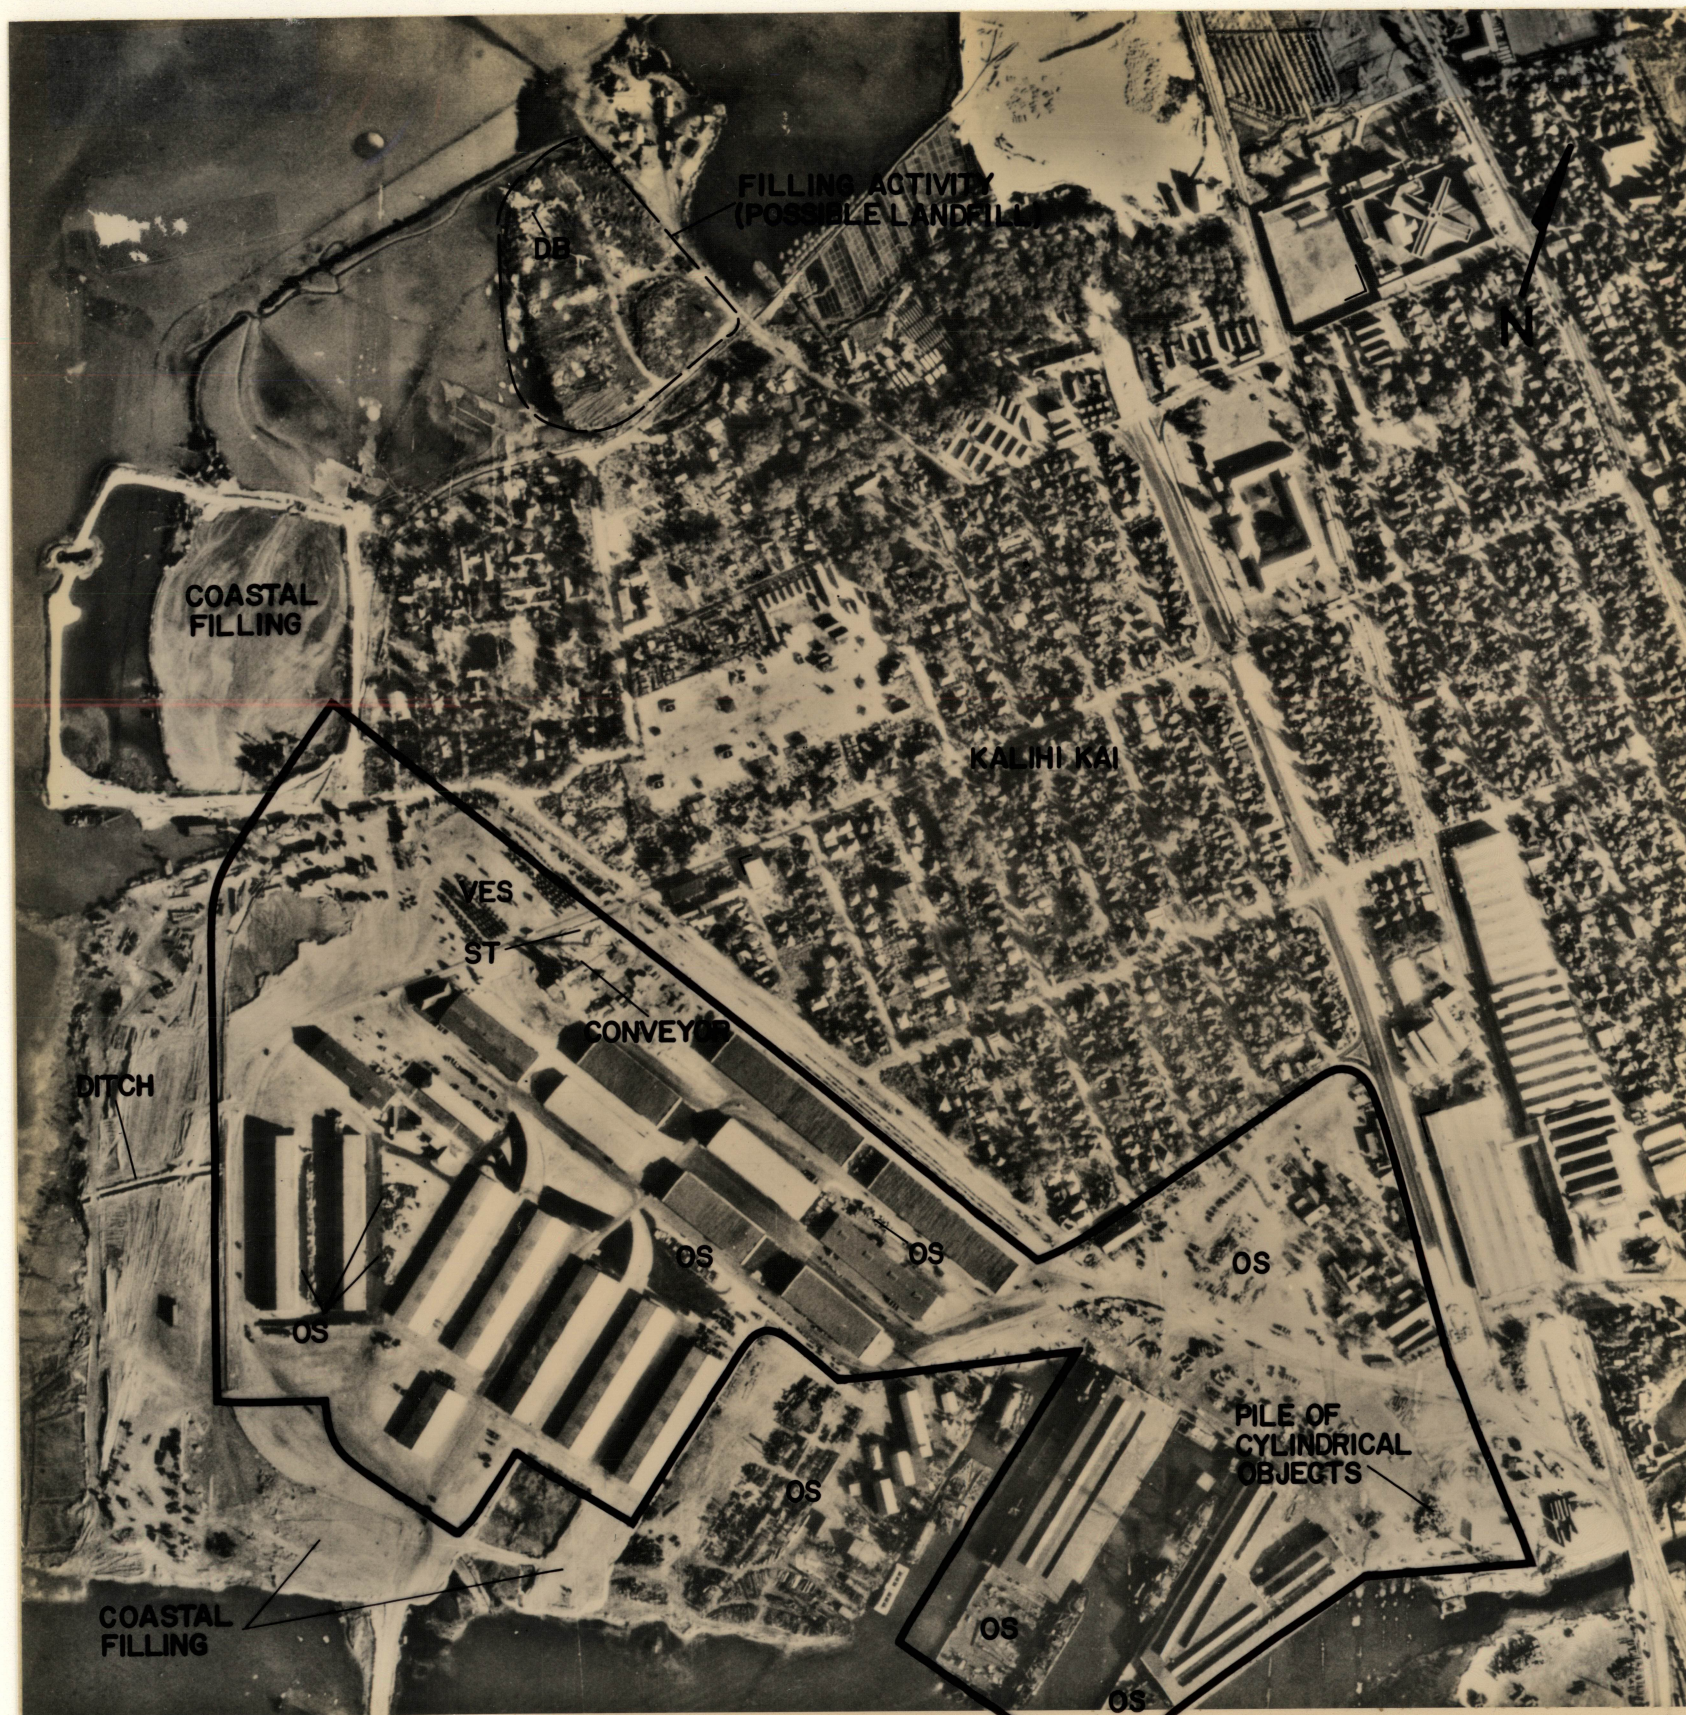
FIGURE 2  
KAPALAMA MILITARY RESERVATION

SEPTEMBER 28, 1944 (FIGURE 2)

The installation appears active in 1944, although construction (not annotated) and coastal filling are still underway around the installation. Open storage (OS) areas are located throughout the installation. The resolution of the imagery is inadequate for positive identification of stored materials; however, much of it appears to be piled containers. Some industrial activity and staining (ST) are present near the conveyor in the northwestern part of the installation. A vehicle and equipment storage (VES) lot is located in this area as well. A pile of cylindrical objects is visible in the southeast corner of the installation. These objects appear too large to be standard drums; however, they are similar in shape.

Filling activity and debris (DB) are present north of the installation, possibly representing a municipal landfill operation. A large ditch is located west of the site boundary.

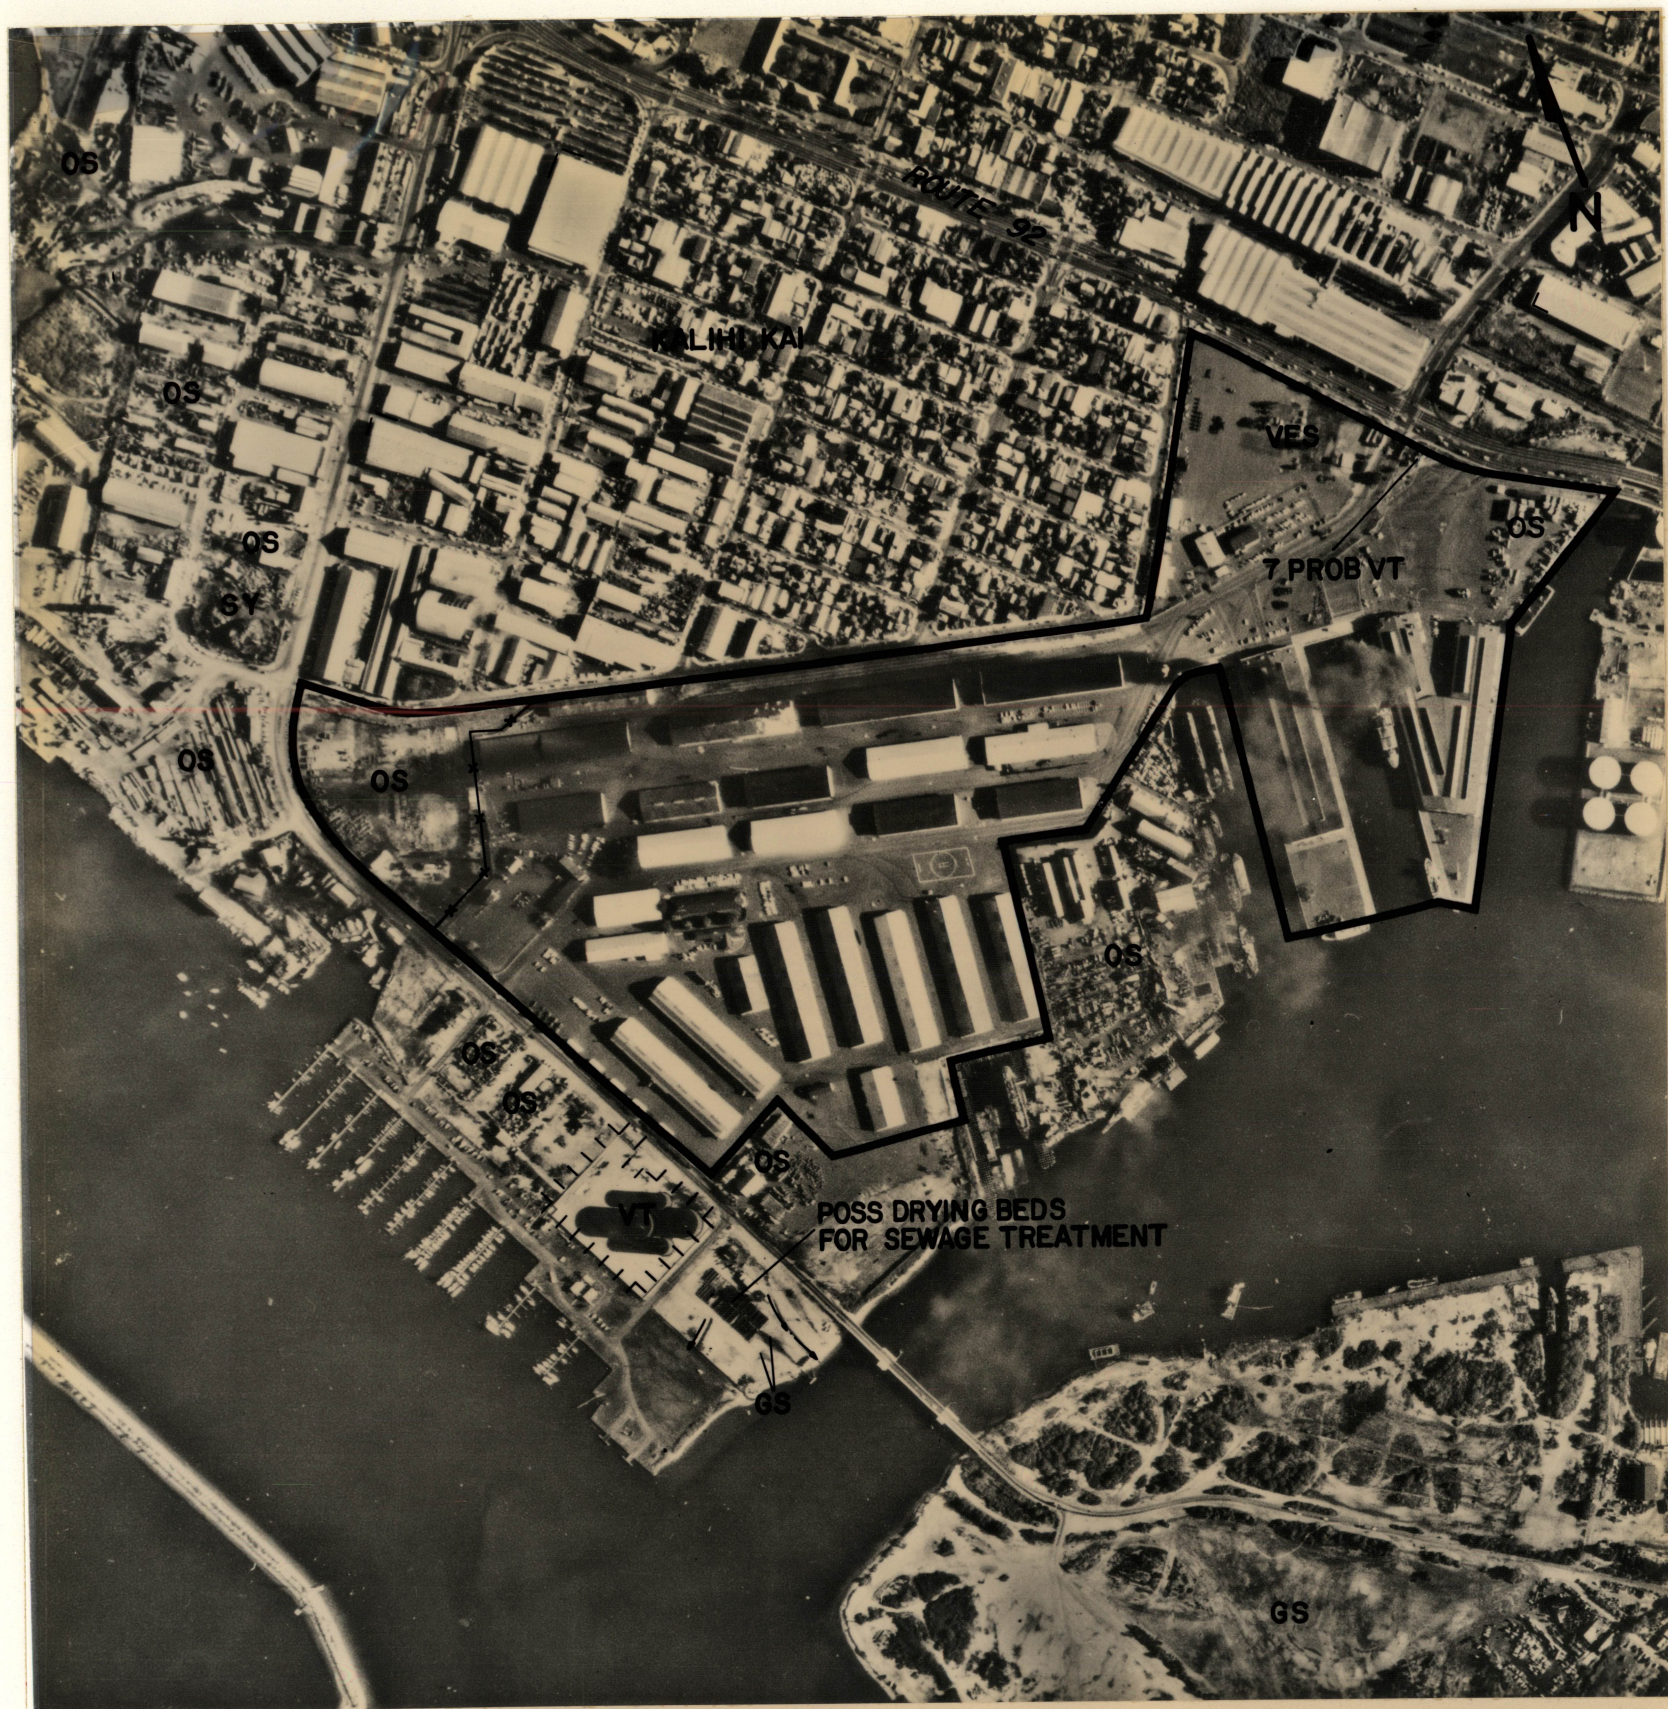
FIGURE 4  
KAPALAMA MILITARY RESERVATION

FEBRUARY 6, 1968 (FIGURE 4)

Photography from 1963 has been analyzed and included in this year of analysis. By 1963, construction and coastal filling activity appeared to be complete. In 1963, a fenced open storage area containing areas of probable stained/wet ground (not annotated) was first seen in the northwest corner of the installation. In 1963, a vehicle and equipment storage area and an open storage area were visible inside the northeast corner of the installation. Seven probable vertical tanks (VT) are located in this area, including two that are open and probably empty.

During 1963 and 1968 little activity is present within the installation; however, eight open storage areas, which all contain probable stained/wet ground areas (not annotated), are visible near the installation. A revetment containing four vertical tanks is present south of the installation. Possible drying beds for sewage treatment are visible in this area (first visible in 1963). Two ground scars are present south of the possible drying beds, suggesting that a breach is present.

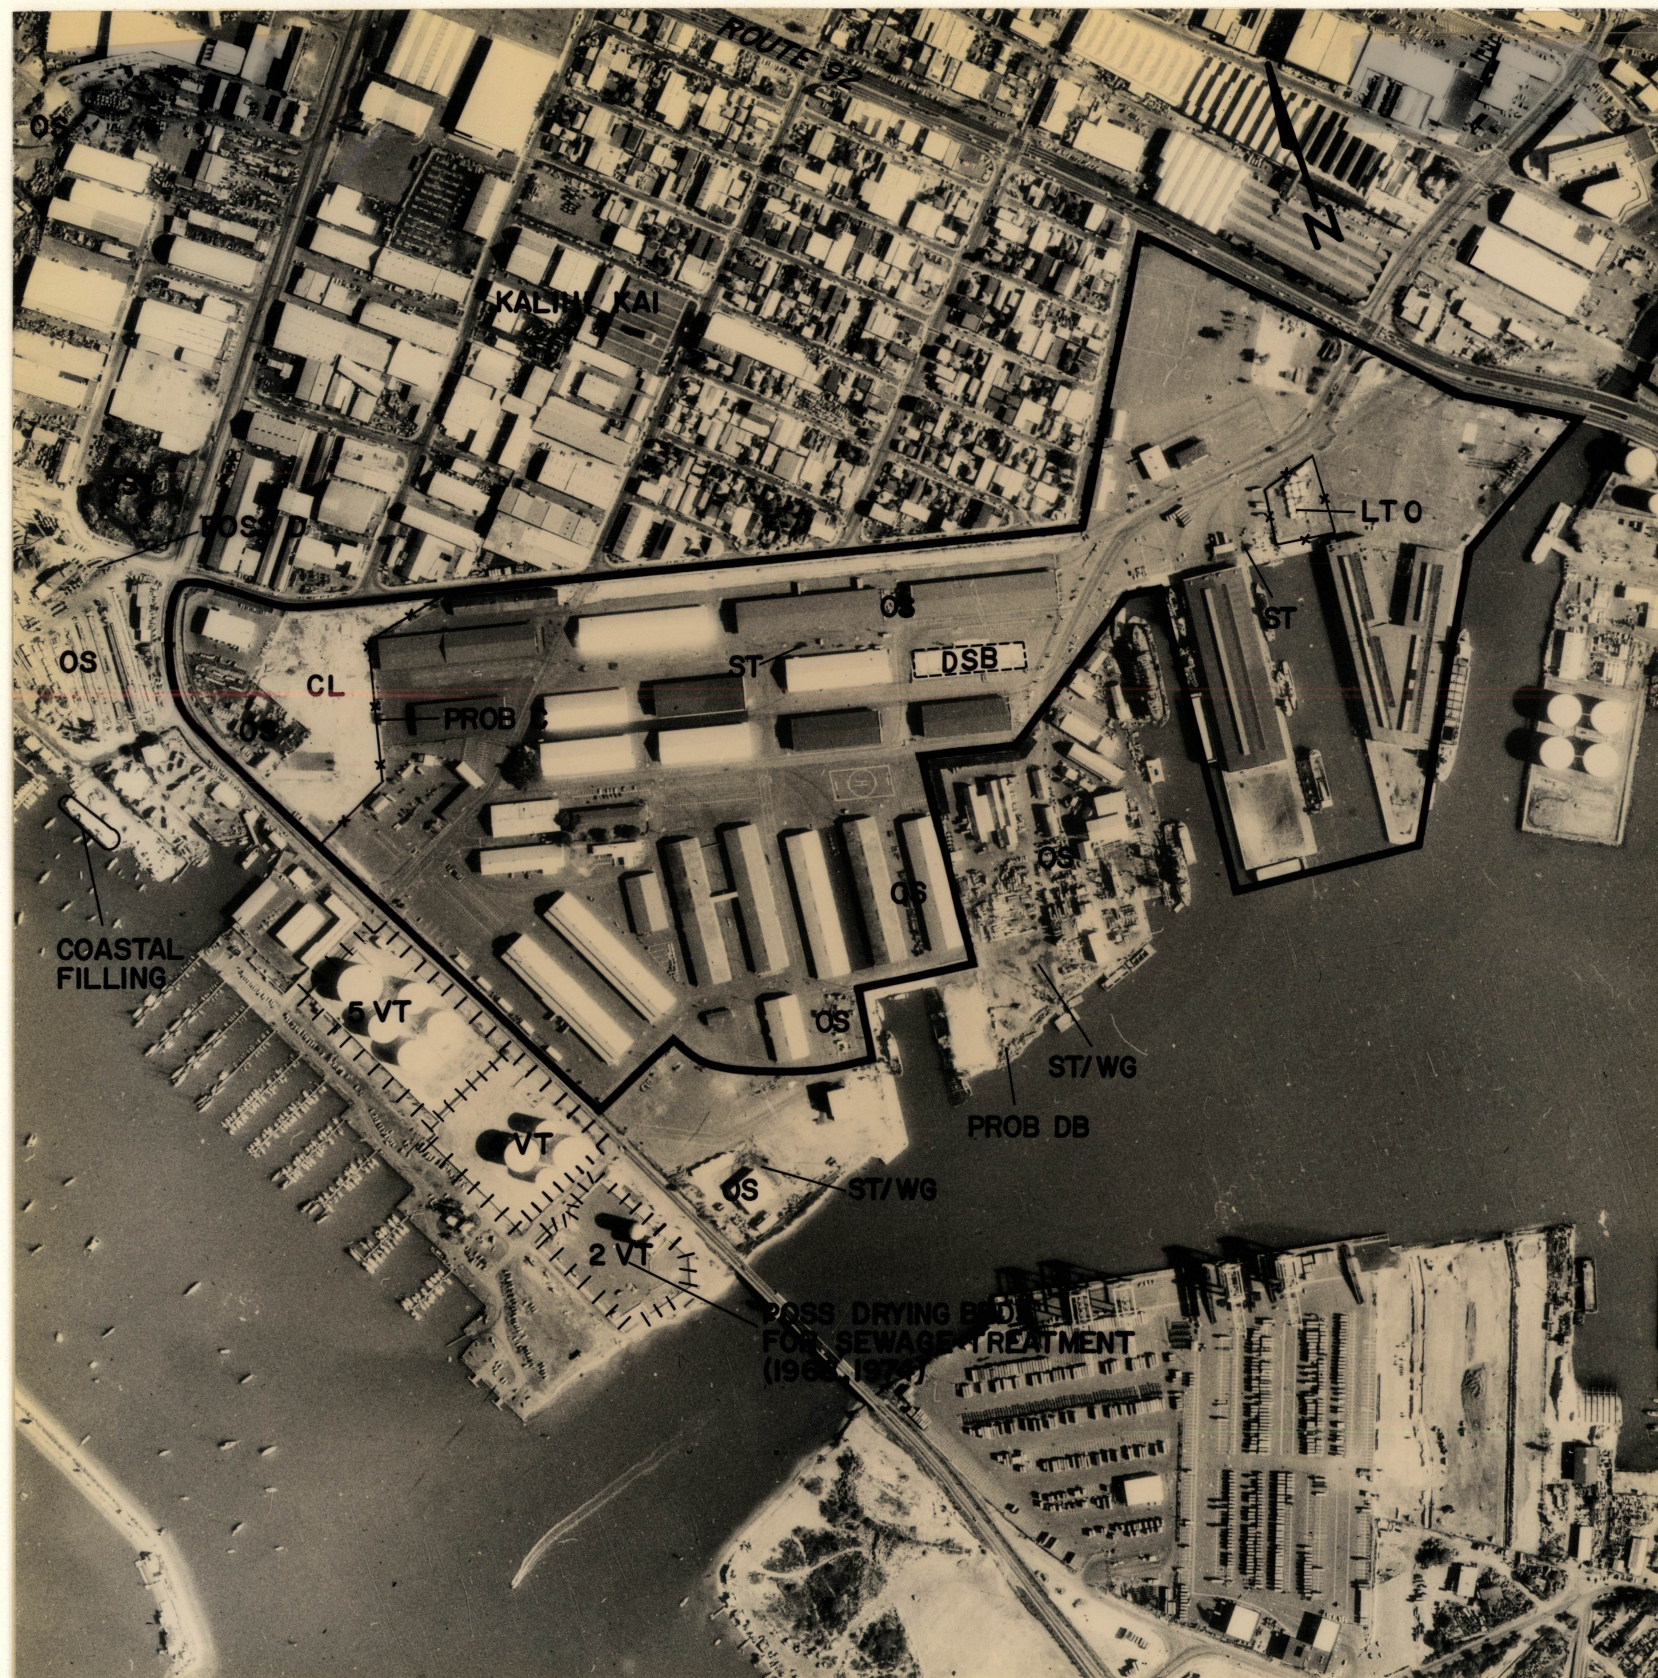
**FIGURE 5**  
**KAPALAMA MILITARY RESERVATION**

JANUARY 29, 1977 (FIGURE 5)

Photography from 1969 and 1974 has been analyzed and included in this year of analysis. By 1977, most of the materials located within the large fenced open storage area visible in 1968 and 1969 have been removed and the area cleared (CL). Approximately 60-120 stacked probable containers (C) are visible adjacent to the cleared area. Few vehicles and equipment are present and one building has been dismantled (DSB). Several isolated stains are present within the site. One stain is located near a fenced area in the eastern portion of the site that contains approximately 14 light-toned (LT), nearly cylindrical objects (O).

In 1969, 1974 and 1977, several open storage areas were located outside the perimeter of the installation. In 1977, a group of approximately 75 to 125 possible drums (D) is present within an open storage area west of the installation boundary. Probable debris and two stained/wet ground areas are present within open storage areas south of the installation boundary. Three revetted areas containing vertical tanks are now present south of the installation boundary. The northernmost tank area was under construction in 1969 and completed in 1974. The southernmost revetted tank area is seen where the possible drying beds for sewage treatment were located in 1974. A small area of coastal fill is present in a small area southwest of the installation.

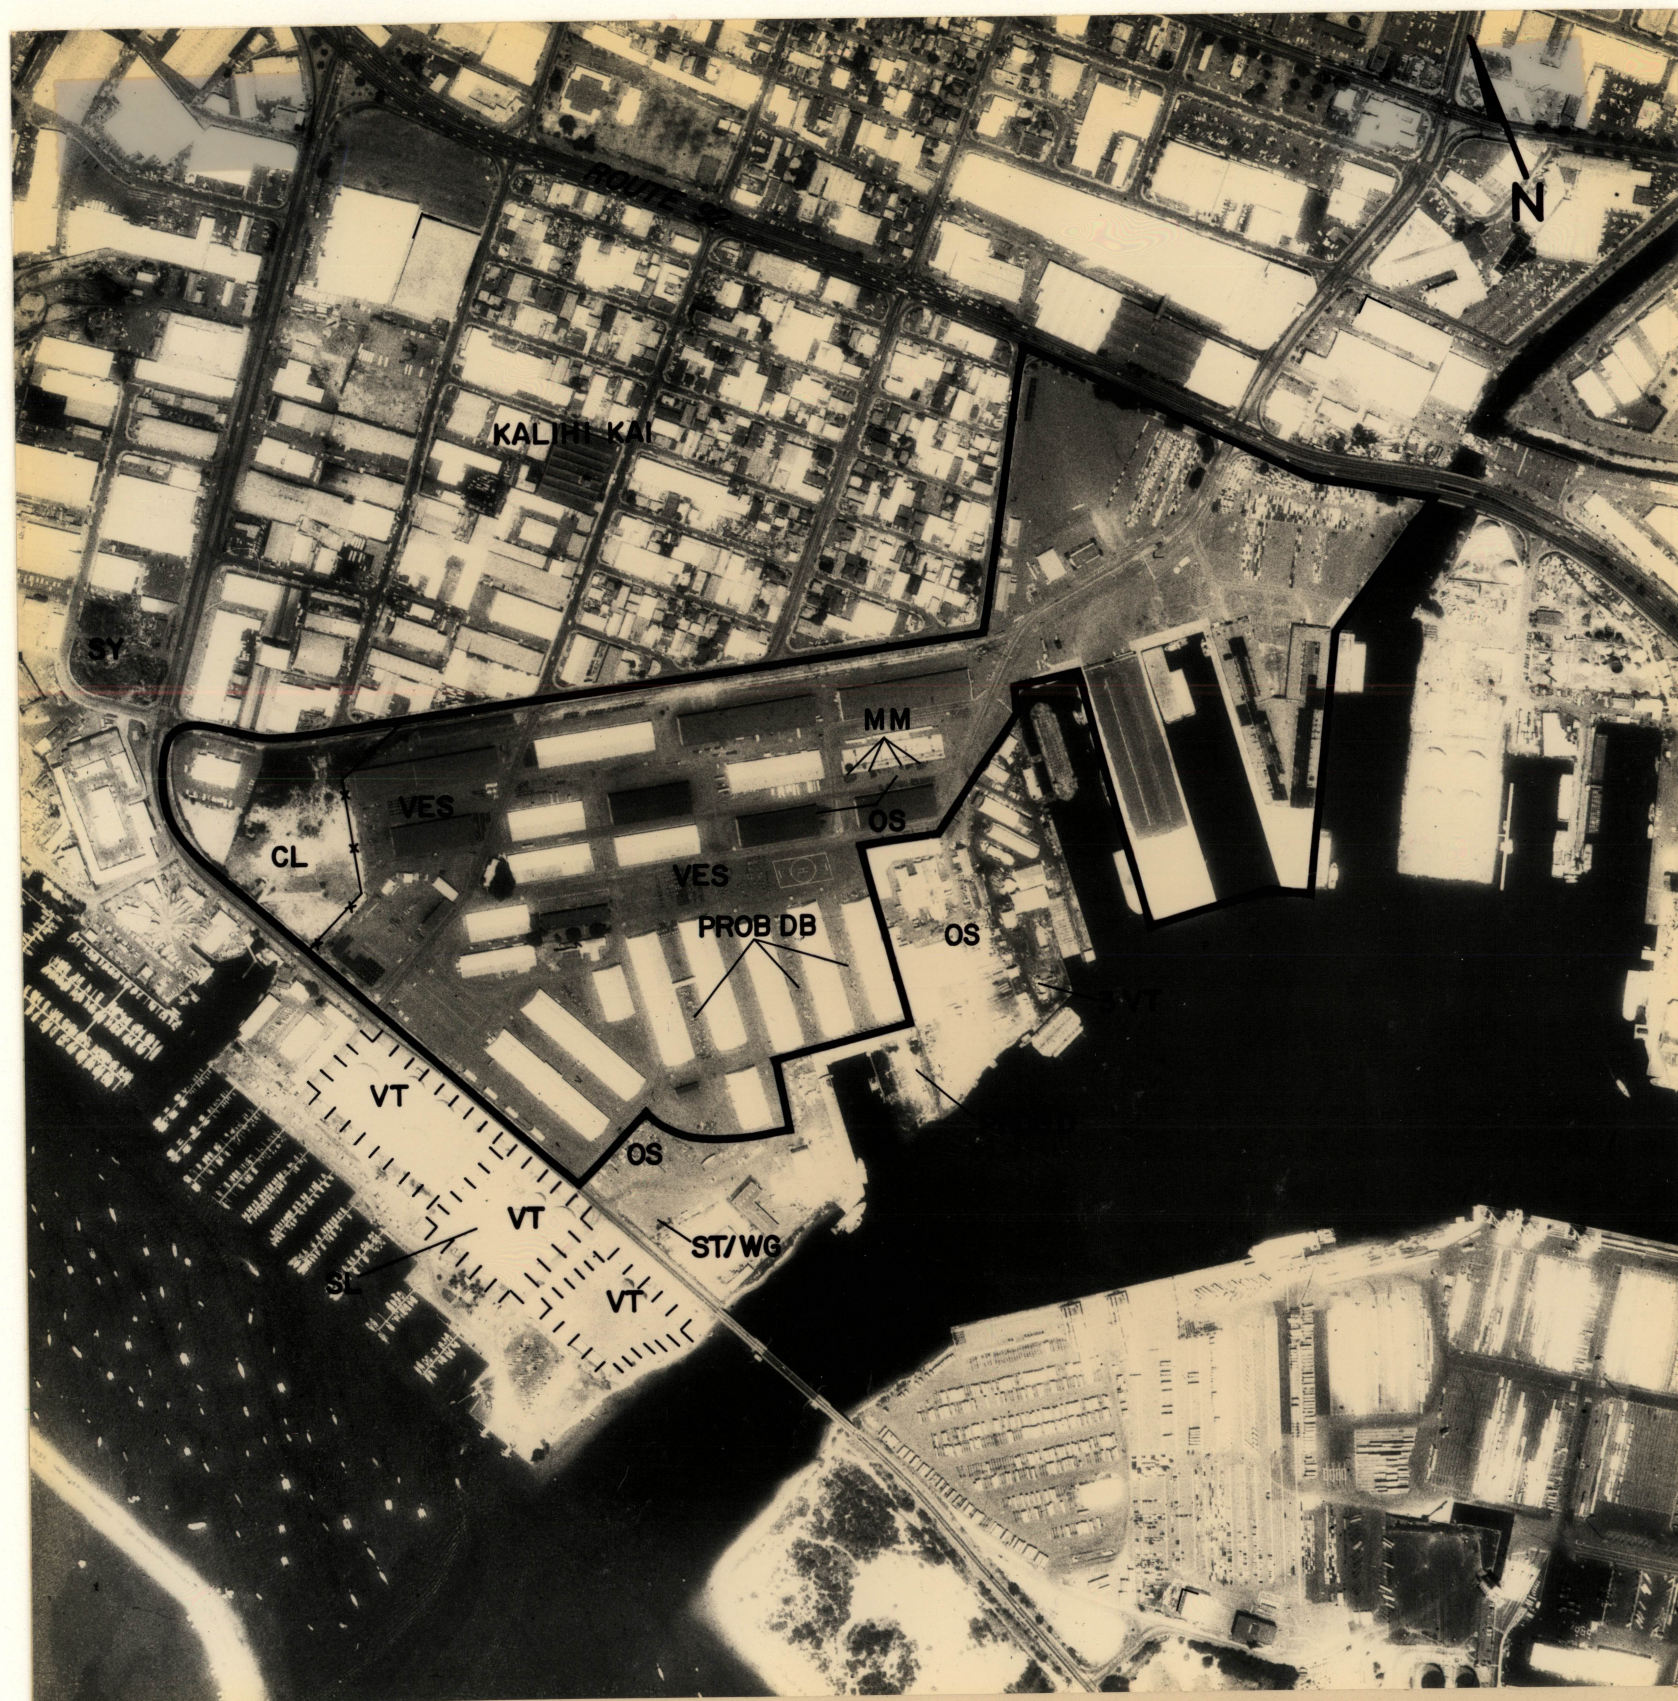
FIGURE 6  
KAPALAMA MILITARY RESERVATION

MAY 24, 1986 (FIGURE 6)

Two vehicle and equipment storage areas are present. The open storage area located within the western perimeter in 1977 is completely cleared. Two open storage areas are present, as are three areas of probable debris (possibly scattered crates). Four small mounds of material (MM) are present near the open storage areas. The fenced area which contained 14 light-toned objects in 1977 is no longer present.

Open storage areas outside the installation also appear vacant at this time; however, three vertical tanks, a group of approximately 30 probable drums and a stained/wet ground area are present in open storage areas south of the installation. The central vertical tank revetment southwest of the installation contains standing liquid (SL).
